Fred H. Schott & Associates

January 11, 2013

Re: Structural Observation of Lompoc Theater, 112-118 North H Street, Lompoc, Ca.

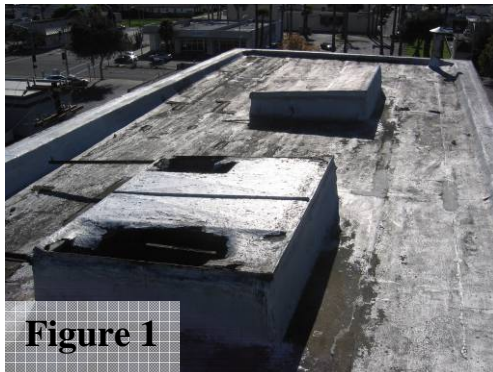
Figure 1

The Fly-Tower roof structure has multiple holes in a large roof hatch which are allowing water and pigeons to get inside the stage area. Based on our previous inspection in 1993, the fly-tower roof has 1x6 straight sheathing boards which can not transfer shear loads. There is also no shear connection between the roof and the walls. The exterior concrete walls have a few minor cracks, but are in good shape. The beams beneath the stage floor appear to be undamaged and the majority of the ceiling beneath the stage does not have water damage so the joists are most likely not damaged either. Towards the north end of the stage, the ceiling beneath shows substantial water damage and mold growth. The joists at this location may be damaged also. The floor sheathing on the stage area has been exposed to weather and pigeon droppings, but appears to be solid. Further opening of the stage may expose mold or rotten wood.

Figure 1: Holes in roof hatch above the stage.

To prevent further deterioration, the holes in the roof hatch need to be fixed. It will need a temporary new plywood cover with flashing and waterproofing or a new smoke hatch cover (both roof hatches will need new smoke hatch covers to bring it up to code).

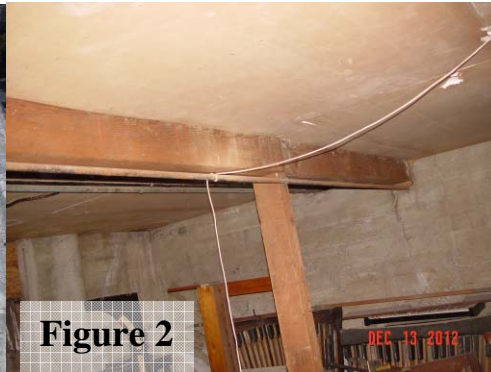
Figure 2

Figure 2: Framing beneath stage; small crack in basement wall.

*The concrete walls in the fly-tower will need to be supplemented at mid-height with a steel beam on three sides and connected to the barrel roof diaphragm on the other side. Any cracks in the concrete walls will need to be filled with epoxy. The stage will need to be opened and any damaged framing will need to be replaced.

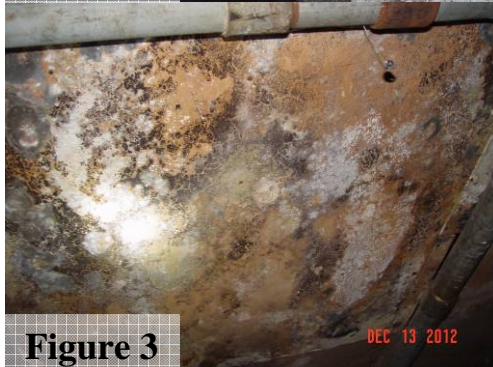
Figure 3

Figure 3: Water damage and mold on ceiling below stage at low point.

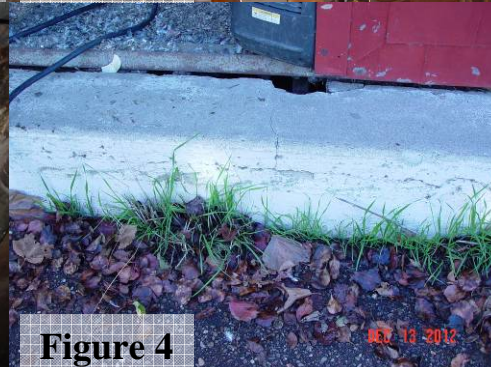
Figure 4

Figure 4: Top of basement wall at South stage door.

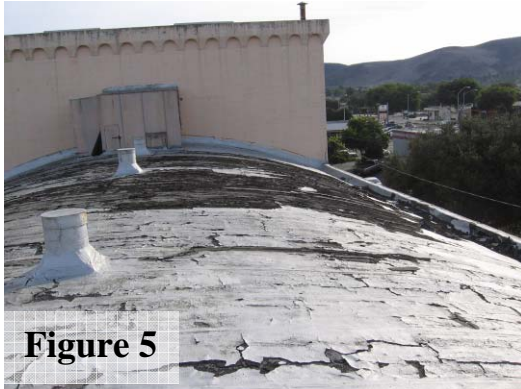
Figure 5

Figure 5: Barrel Roof looking east with evaporative cooler and fly-tower beyond.

The large evaporative cooler should be removed from the barrel roof over the auditorium.

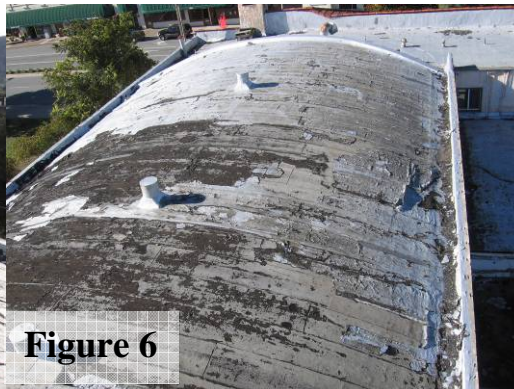
Figure 6

Figure 6: Barrel roof looking west.

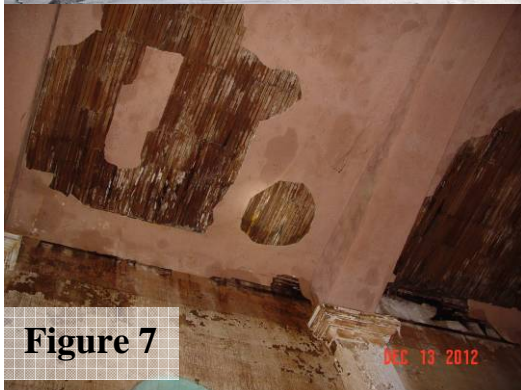
Figure 7

The Auditorium Barrel Roof has been leaking along the North and South sides. The roof sheathing, roof joist, and ceiling joists along the exterior walls have been damaged by the water and show signs of rot. Large pieces of plaster have fallen from the ceiling to expose wood lath with signs of water exposure. The steel bowstring trusses that support the roof have surface rust due to the roof leaks, but do not appear to be rusted enough to be structurally compromised. The roof has 1x6 sheathing boards which are unable to transfer shear loads to the side walls and there is no positive shear connection between the roof and sidewalls. Based on our previous inspection in 1993, there is no blocking between the roof joists above the trusses. A large evaporative cooler sits on the barrel roof near the fly-tower. The orchestra pit in front of the stage has an excavated area beneath the pit cover. The joists and sheathing covering the pit show signs of water damage.

Figure 7: Water Damage at North Wall.

To prevent further deterioration and rusting, the north and south edges of the roof need to be sealed. Due to water damage, the roof rafters, ceiling joists, and 1x6 straight sheathing needs to be replaced for 4 feet along these walls then covered with a waterproof membrane. Currently, the bowstring trusses have surface rust and do not appear to need supplementation at this time. If left exposed to the elements, the trusses will continue to rust. Painting the trusses with a rust-inhibitor will also help prevent further rusting.

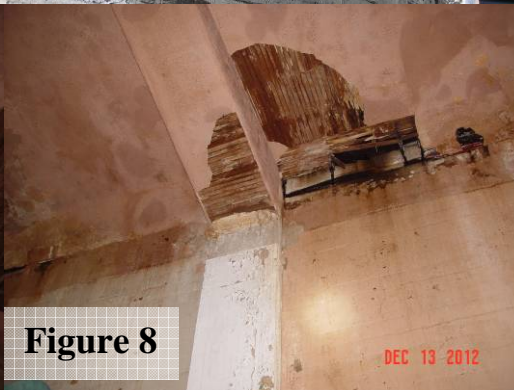
Figure 8

Figure 8: Water Damage at South Wall.

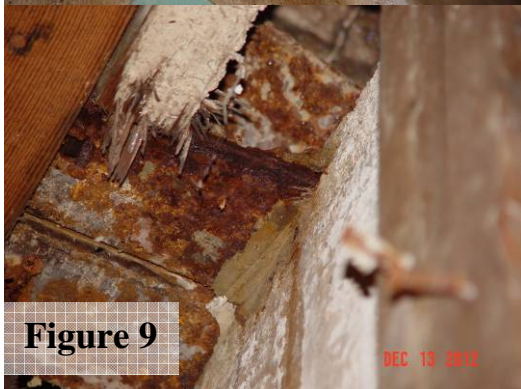
Figure 10

Figure 9: Surface rust on bottom chord of bowstring truss.

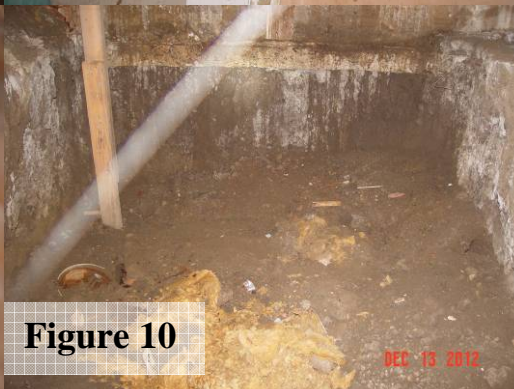
Figure 10: Exposed ground at excavation in orchestra pit.

Any cracks in the concrete walls will need to be filled with epoxy. The excavated portion of the pit wall needs to be filled with a sand-cement slurry and any damaged joists or plywood covering the pit will need to be replaced.

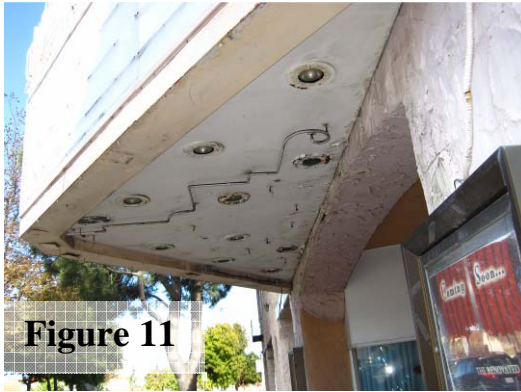
Figure 11

The Marquee over the sidewalk consists of a wood frame with a thin sheet metal exterior held up by three rods which are connected to the concrete wall. There are numerous holes in the top of the marquee and the exposed wood frame shows serious water damage and rot. There does not appear to be a drain for the water that gets caught in the marquee. The rods and metal front show some minor surface rust.

Figure 11: Bottom of the Marquee.

The marquee is also a safety hazard and should be taken down immediately. It can be supported from below to disconnect the rods, then removed from the building. The wood framing in the Marquee is rotten and deteriorating. The sheet metal front can probably be salvaged and reattached with new framing during rehabilitation of the building.

The marquee had an asphalt emulsion over the joists which prevented us from viewing the connections, but the joists that were exposed showed substantial water damage and rot. In this weakened state, the marquee could break free (or pieces of it) from the building and fall on the sidewalk below. It currently is a safety hazard and should be taken down immediately. It can be supported from below to disconnect the rods then the marquee can be safely removed from the building. The sheet metal front can probably be salvaged and reattached during rehabilitation of the building. The wood framing will have to be completely replaced with new joists, plywood, a ledger or angle for shear transfer and a waterproof membrane.

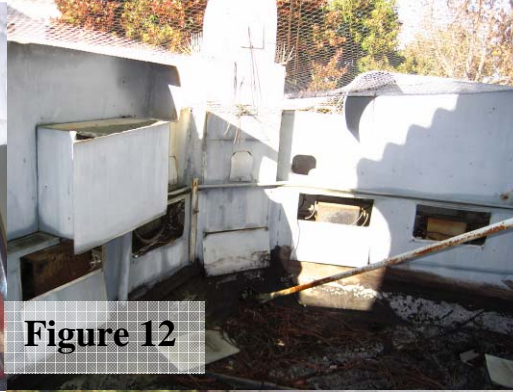
Figure 12

Figure 12: Interior Framing of the Marquee.

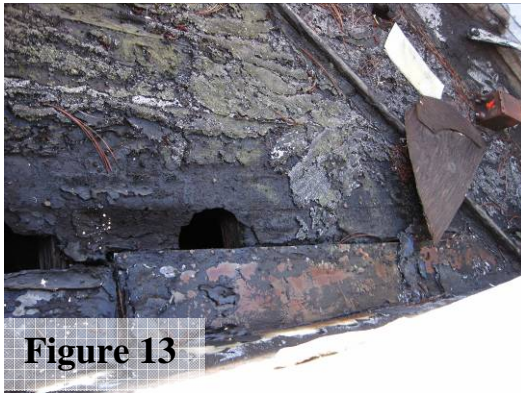
Figure 13

Figure 13: Water damage and holes in Marquee wood frame.

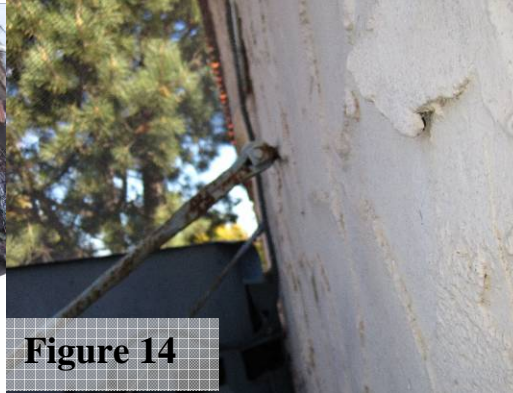
Figure 14

Figure 14: Rods connecting Marquee to concrete wall.

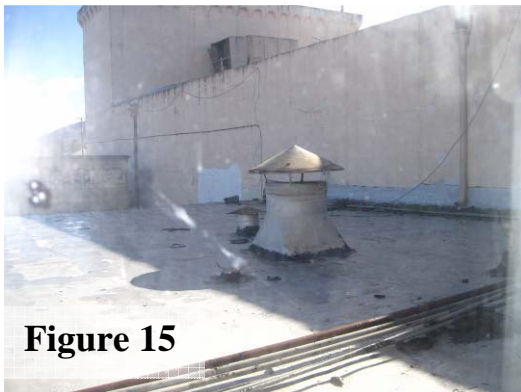
Figure 15

The first floor roof structure over the commercial space did not show any damage from above. Based on our previous inspection in 1993, this roof has 1x6 straight sheathing above the roof rafters and 1x6 diagonal sheathing above the ceiling joists. The concrete walls are not tied back into the diaphragm. Our previous inspection also indicated a sagging beam that had been propped up with a cross support. There currently is no standing water at the sag location on the roof.

Figure 15: South side of 1st story roof.

To bring this portion of the building up to current code, seismic ties and blocking will need to be added to connect the concrete walls to the roof diaphragm. The sagging beam will need to be properly supplemented and the cross support removed. These additions will be made from below and should not disturb the waterproof membrane if re-roofing is done before these items are implemented.

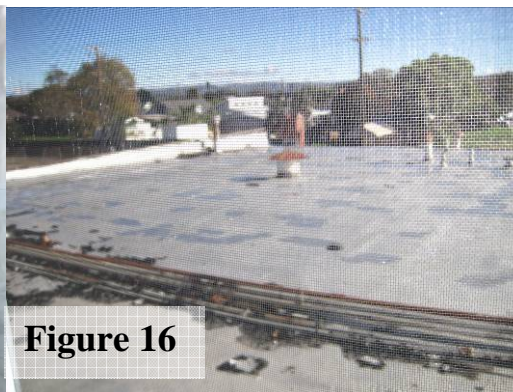
Figure 16

Figure 16: North side of 1st story roof.

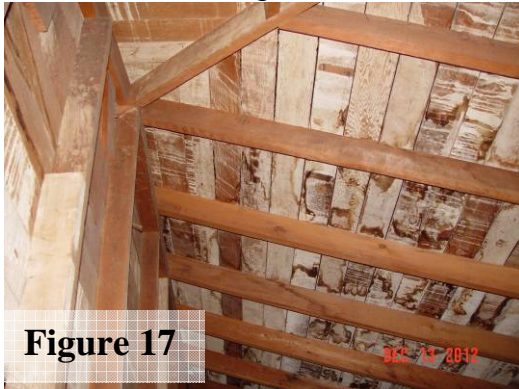
Figure 17

Figure 17: Roof rafters and 1x6 straight sheathing beneath tile roof.

To bring this portion of the building up to current code, plywood will need to be added over the existing roof framing for the flat (east) portion of the roof. The outside of the parapet wall separating the raised tile roof from the flat roof will also require plywood. A steel beam will be added above the roof to support the overloaded joists below. It will sit on two new 4x6 posts with new footings which line up with existing walls. The parapet wall will then be furred out to cover the new beam with diagonal 2x4s and plywood. A continuous angle or bent plate will need to be added to the roof edges to connect the concrete walls to the roof diaphragm. The north and south concrete walls need blocking and ties to the roof diaphragm. A strap will need to be installed along the east side of the flat roof above the

*The remainder of the required structural upgrades can be completed after re-roofing has occurred. The west portion of the roof has Spanish tile roofing. To avoid disturbing the tile, plywood is required on top of the ceiling joists, in the attic space. The portion of the parapet wall in the attic space will also need plywood and blocking to transfer shear loads. A continuous angle or bent plate will need to be added along the front wall to connect it to the new ceiling diaphragm. Steel struts will connect the front concrete wall to the flat roof diaphragm. Below, the second floor joists will need ties and blocking to connect the second floor diaphragm to the concrete walls on the east and west sides. The existing nailer at these locations will also need additional fasteners to transfer shear loads into the concrete walls. The north and south walls will need a continuous angle or bent plate connecting the floor diaphragm to the walls. Blocking and drag-ties need to be added at each side of the stairs and at various locations where stairs have been removed. As noted above, the wall between the upper and lower roofs needs plywood installed on its exterior. The lower portion of the wall which overlaps the lower roof can be installed on the inside of the wall. This wall will then require stucco or some other form of exterior finish. Two steel moment frames with new footings are required at the ground floor along the front of the building to resist seismic loads. The existing cracks in the concrete walls will need to be filled with epoxy.

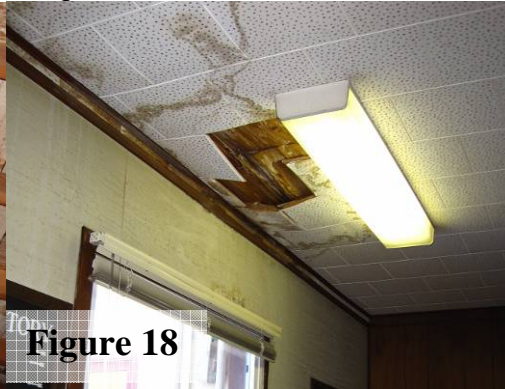
Figure 18

Figure 18: Active leak in hallway at top of stairs.

To prevent further water damage the existing leaks need to be fixed.

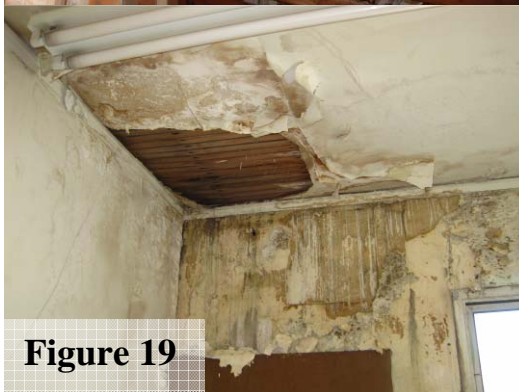
Figure 19

Figure 19: Active leak at edge of pop-up in tile roof.

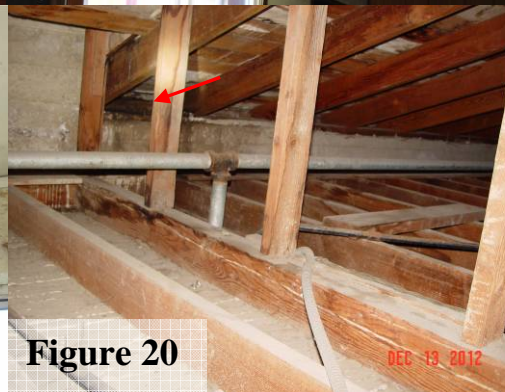
Figure 20

Figure 20: Active leak at edge of pop-up in tile roof from attic.

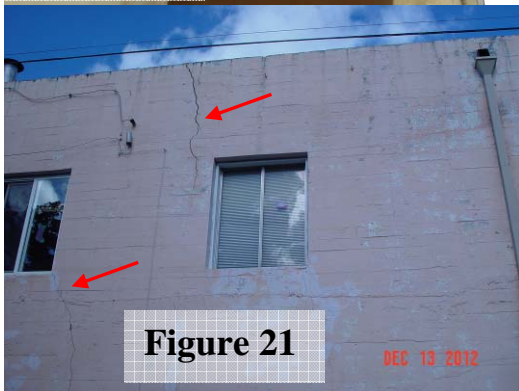
Figure 21

Figure 21: Cracks in exterior concrete wall.
